Manhole Inspection Summary

Manhole # S17I__011MH

Insp Date: **10/9/07 9:22 AM**

Location Address: **2330 BALTIMORE ST**

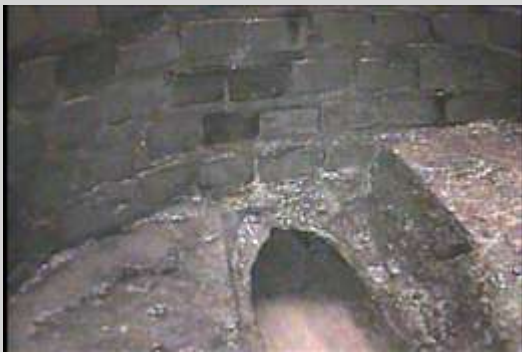
12 O'Clock Outflow

Pipe Height: **8.4** (in.) Rod and Bar (Angled)
Pipe Material: **Clay** ☐ Pipe Lined
Invert Depth: **11.61** (ft.) Flow Characteristics: **Fast**
Deposits: ☒ None ☐ Mud ☐ Sludge ☐ Debris ☐ Grease
Silt Depth: (in.) Deposits Extent:
Infiltration: **None** Pipe Seal Cond: **Sound**

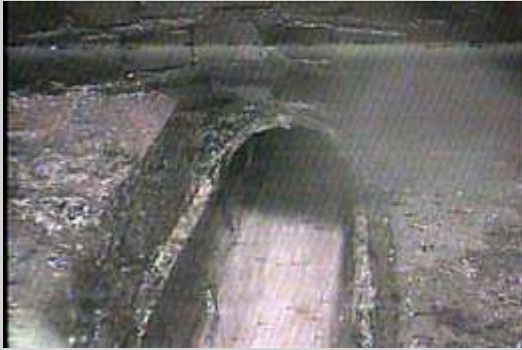
6 O'Clock Inflow

Pipe Height: **8.4** (in.) Rod and Bar (Angled)

Pipe Material: **Clay** ☐ Pipe Lined

Infiltration: **None** Pipe Seal Cond: **Sound**
